# EXPLORING THE 3D PRINTING OF METAL VACUUM SEALS

The Research & Feasibility team of Settels Savenije's development department took part in AddLab's Design Challenge 2015 with a self-sealing vacuum seal designed for reducing construction space in high-tech vacuum systems for semicon-related and process industries.

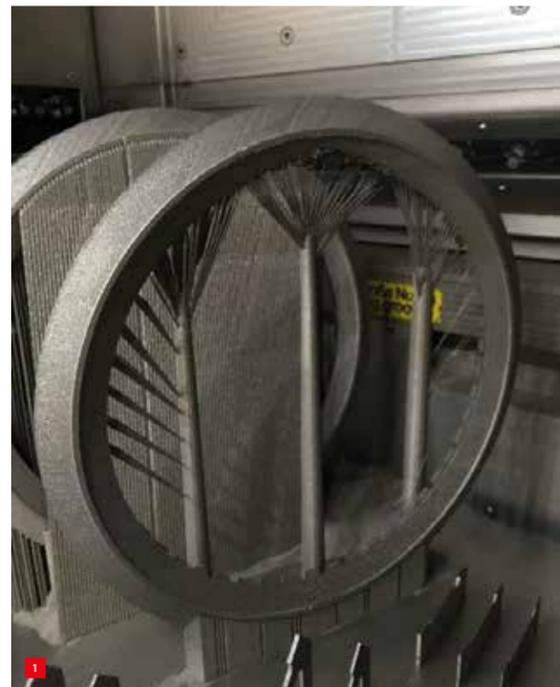
1 Single seal printed in an upright position supported by the so-called tree structures. In the back, the same seal can be seen printed with full supports. For this last type of support, note the undesirable amount of printing powder that remains after cleaning.

removing the structures is an added benefit. Figure 1 shows the single seal on the printer after the 3D printing process has finished and most of the printing powder has been removed.

The prototypes made during this first print job demonstrate the difficulty of printing this design and the bad manufacturing because of the choice of support structures (see Figure 1). The following observations can be made. A full structure support leads to:

- 1) Printing powder remaining in the structure.
- 2) A lot of post-processing time needed to remove structures and clean up the part.

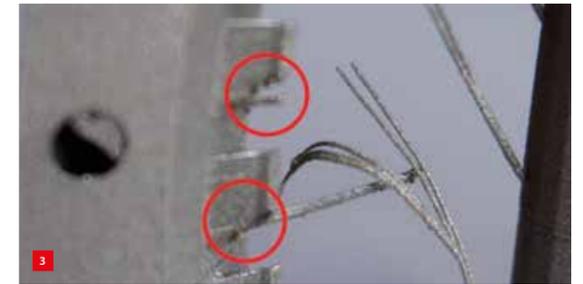
3 Clamp fingers with defects due to a (3D-printing-specific) mismatch of length-to-width ratio.

2) Fragile branches in the tree structure which have unfortunately snapped (see Figure 3).

reducing the number of 'clamp fingers' (see Figure 3). This new support strategy combined with an adjusted seal design provided the basis for optimising the vacuum seal. The result of this print job can be seen in Figure 4.

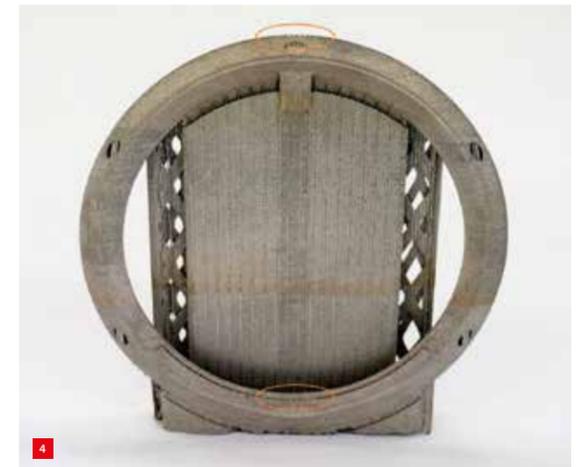
4 Result of the second print job, with optimised support structures and adjusted seal design.

This second print job provided additional lessons on 3D printing practice. Despite the new support structures, there were still some areas with a rough surface (see the marked areas in Figure 4). The reinforced support could be easily removed with the help of the perforations. There were a sufficient number of perforations and no further optimisation was required.

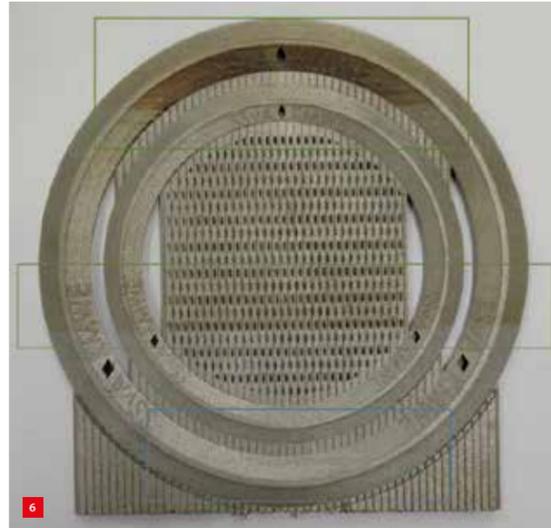
7 Measurement data (using the CAD model as a reference) showing the deformation of the lower side of the seal.

1. There was some deformation on the bottom of both seals (see the area marked in blue in Figure 6 and 7). A cause could not be determined immediately, although shrinkage of the material was suspected. After analysing the print job, the new slicer and its new parameters were found to be the cause. Slicer software is normally used to partition the product in thin layers that are printed sequentially.
